CF6 JET ENGINE PERFORMANCE IMPROVEMENT - HIGH PRESSURE TURBINE ROUNDNESS

W.D. Howard and W.A. Fasching

GENERAL ELECTRIC COMPANY

JANUARY 1982

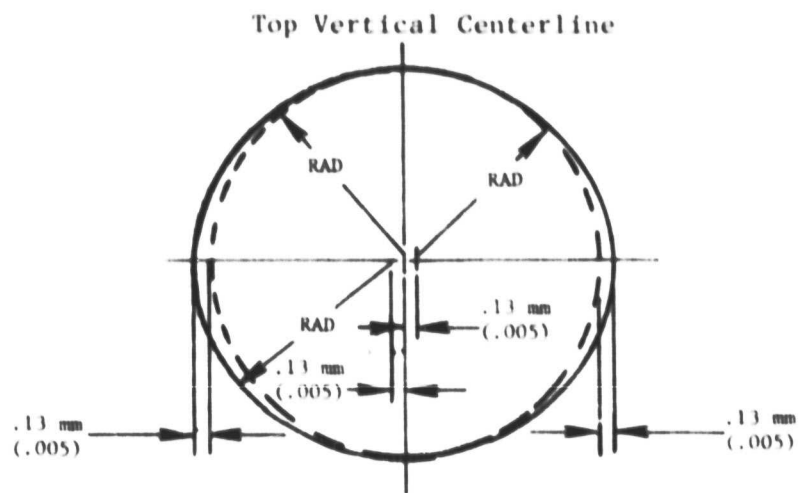
Figure 81. Shroud Grind to Eliminate Rubs Caused by Improved TMF Repeatable Out-of-Roundness.

The effects of out-of-roundness are local rubs. By removing material from the shrouds only in the areas adversely affected by the repeatable out-of-roundness, rubs can be eliminated and the overall effect on clearance minimized. Such a shroud shape, obtained by a preferential grind, is currently used by the CF6-50C engine and will be required with the roundness/clearance improvement hardware (Figure 81).
